# MESHING REPORT

## 啮合报告

| ITEM NO.序号 | PART & REV. NO.<br>零件号 | MOUNTAING DISTANCE<br>安装距 | ACTUAL BACKLASH<br>实际隙 | SCETCH DRAWING草图 |
|---|---|---|---|---|
| 1 | TB3026 & TB3029 | L1=30.00 | 0.10 | / |

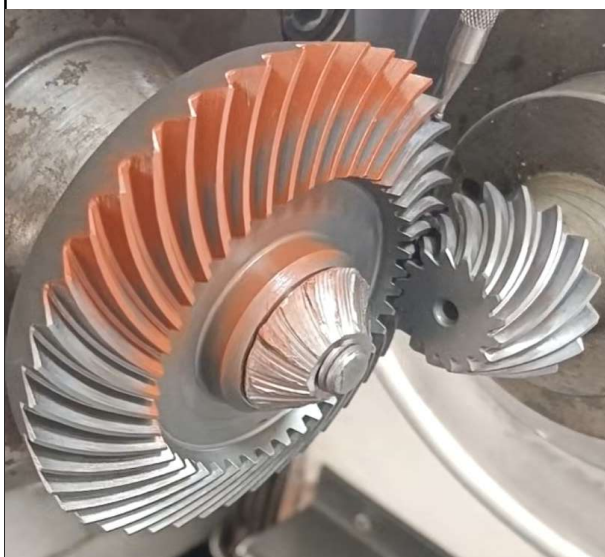
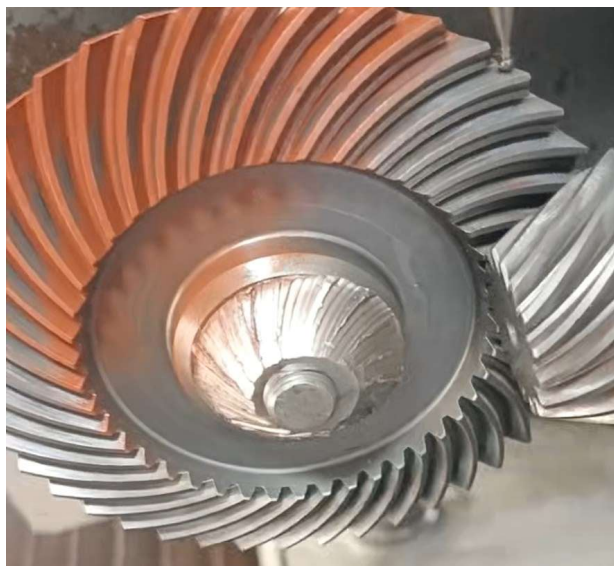
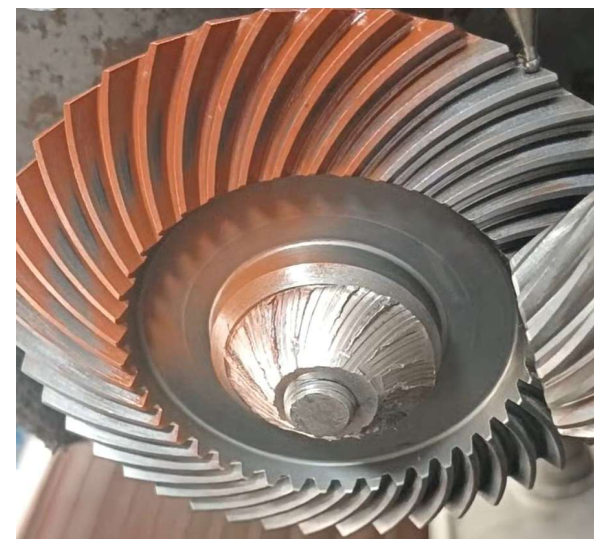
TESTING PICTURES拓印图

| ITEM NO.序号 | PART & REV. NO.<br>零件号 | MOUNTAING DISTANCE<br>安装距 | ACTUAL BACKLASH<br>实际隙 | SCETCH DRAWING草图 |
|---|---|---|---|---|
| 2 | | L2=47.00 | | |
