# MESHING REPORT

## 啮合报告

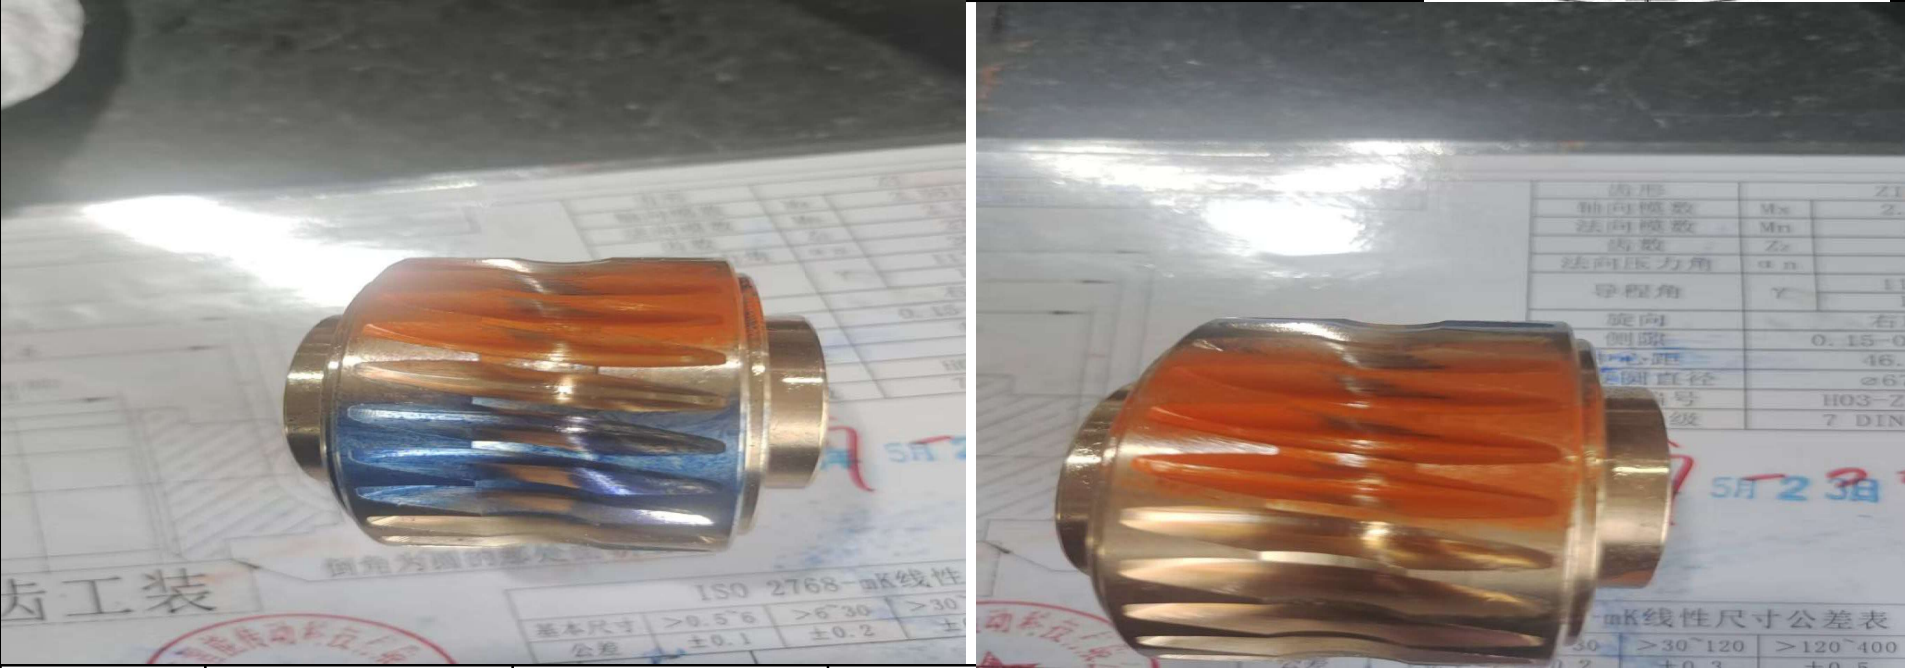
| ITEM NO.序号 | PART & REV. NO.<br>零件号 | CENTER DISTANCE<br>安装距 | CENTER HEIGHT 中<br>心高 | ACTUAL BACKLASH<br>实际隙 | SCETCH DRAWING |
|---|---|---|---|---|---|
| TESTING PICTURES拓印图 | | | | | |

| ITEM NO.序号 | PART & REV. NO.<br>零件号 | CENTER DISTANCE<br>安装距 | CENTER HEIGHT 中<br>心高 | ACTUAL BACKLASH<br>实际隙 | SCETCH DRAWING |
|---|---|---|---|---|---|
| 1 | s5904337 | 46.25 | 24 | C=0.21 | |
| INSPECTOR 质检<br>员 | Zheng | RESULT 检验结果 | ok | DATE日期 | 2025/5/24 |
